# CONSTRUCTION MATERIALS

Alyssa Moffitt  
Fall 2019

STORMWATER MANAGEMENT  
NEW YORK  
BOTANICAL GARDENS

NATIVE GARDEN  
WETLAND &  
RETENTION BASIN

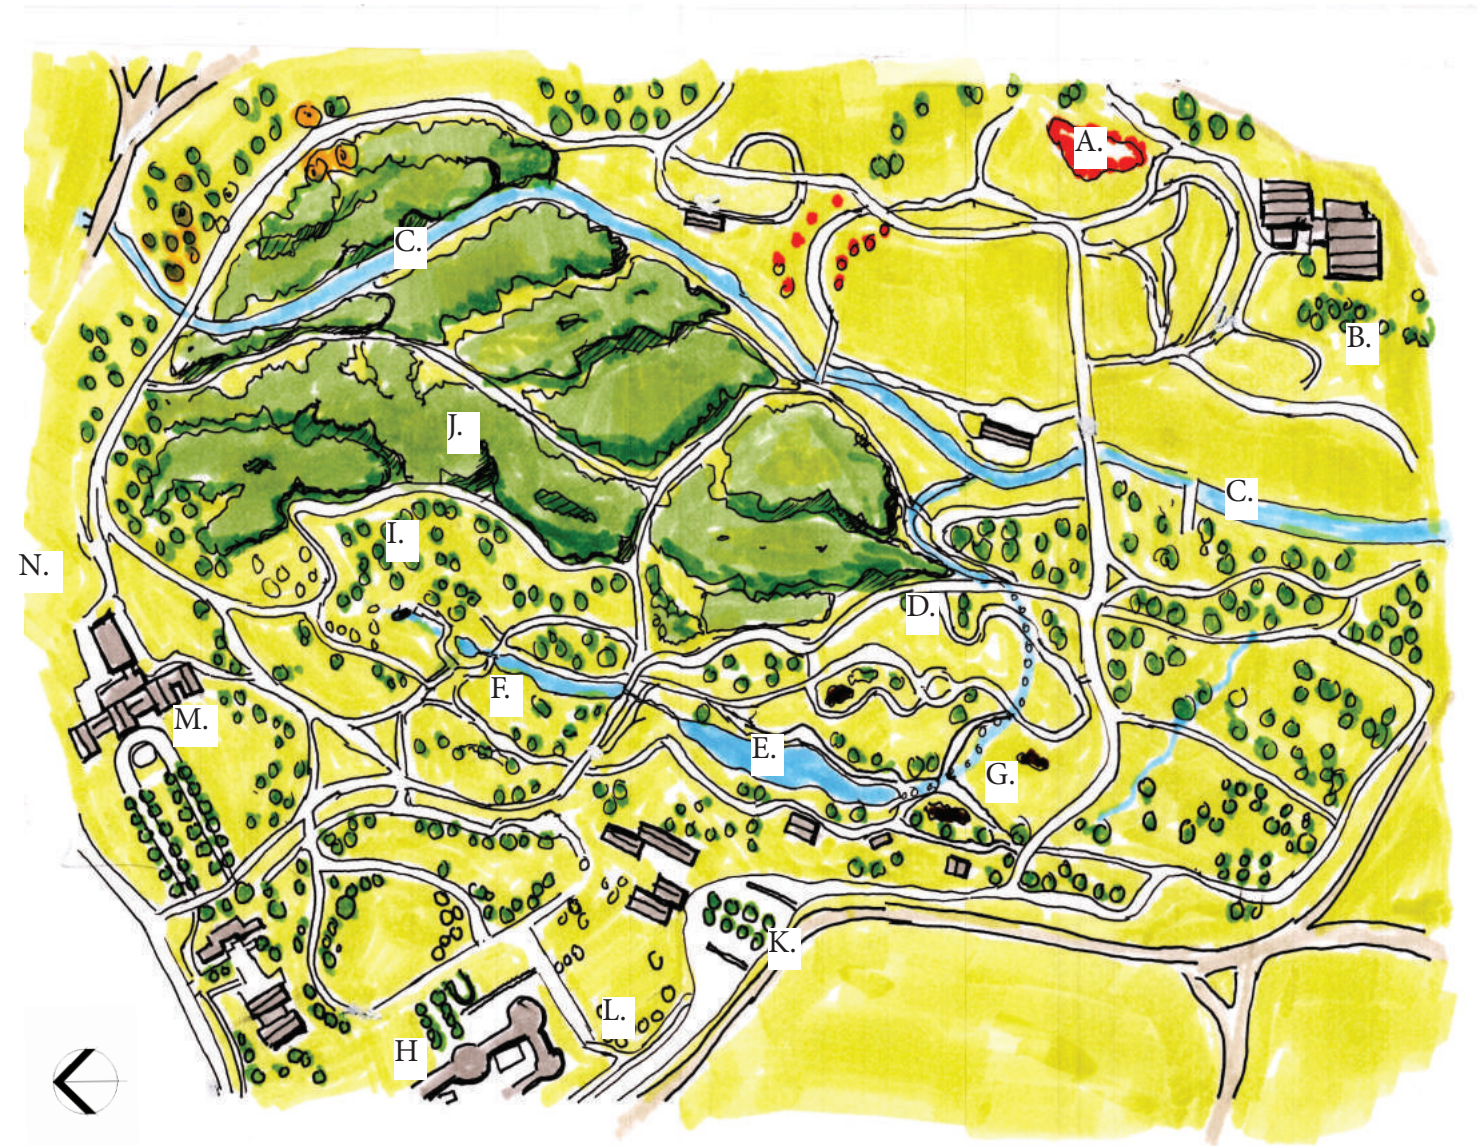
NOTES: NYBG MAP

- A) Peggy Rockefeller Rose Garden
- B) Benenson Ornamental Conifers
- C) Bronx River
- D) Azalea Garden
- E) Mitsubishi Wild Wetlands
- F) Native Gardens
- G) Picnic Area
- H) Haupt Conservatory
- I) Rock Garden
- J) Thain Family Forest
- K) Conservatory Gate
- L) Leon Ivy Visitor Center

- M) Mertz Library Art Gallery
- N) Twin Lakes (not shown)

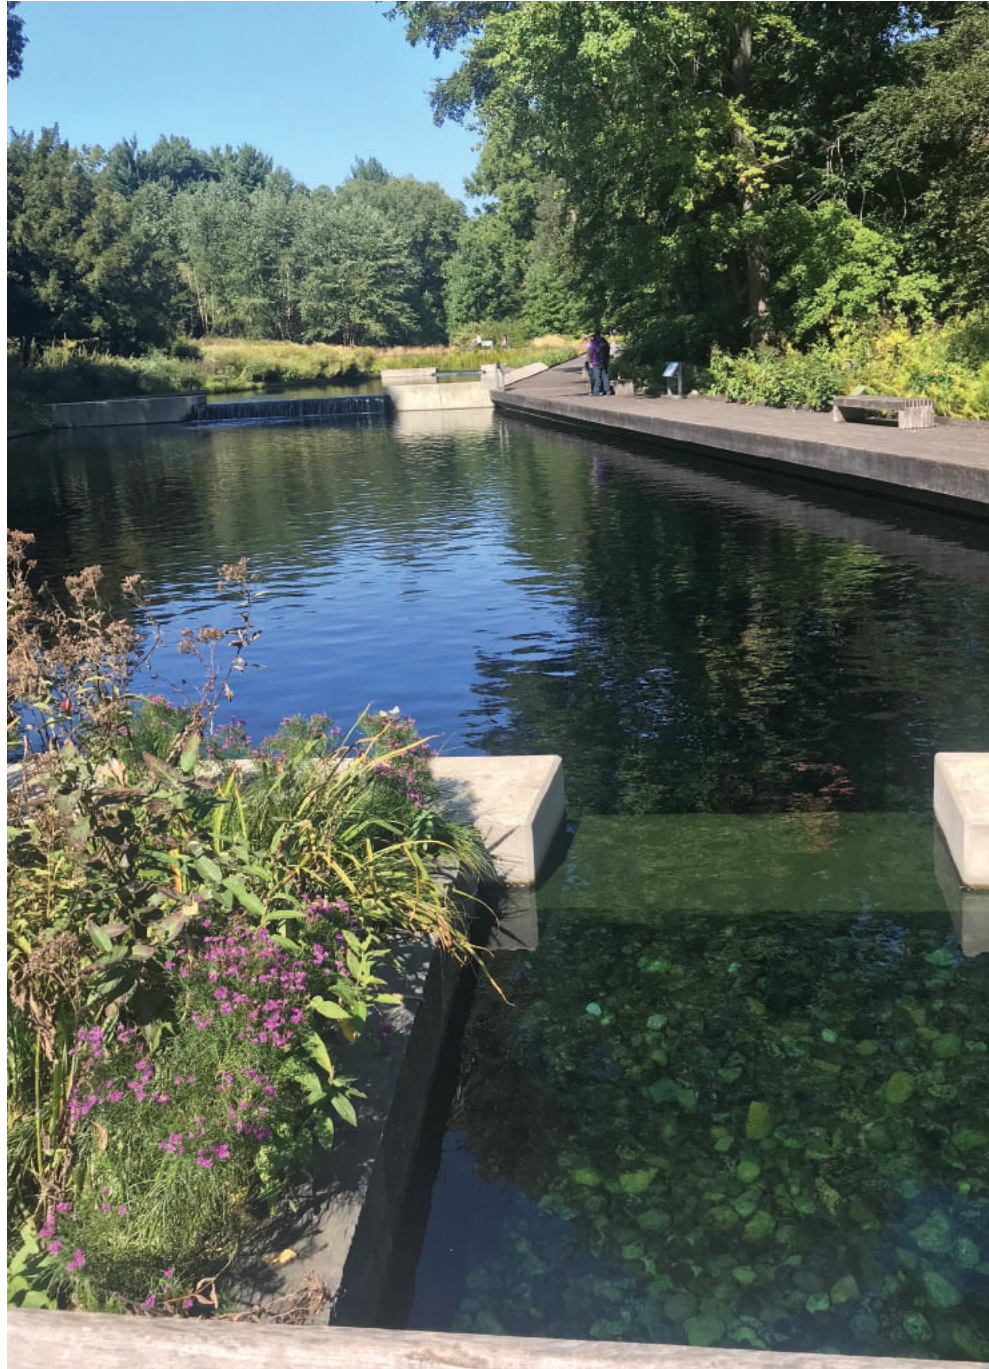
A cistern underneath the impermeable water feature carries a quarter acre water body. The sand and gravel pump moves 350,000 gallons of water back up to circulate before running downstream and 3 large cisterns hold stormwater overflow. The operating level of the lower water basin can be lowered to accommodate stormwater and is designed to have the capacity of on demand stormwater retention and zero runoff. (CMS Water Collaborative). The wetland was designed to contain 5 times the cleansing space for the water feature with a reserve area of clean water. (Sheila Brady, FASLA, LAM June 2014)

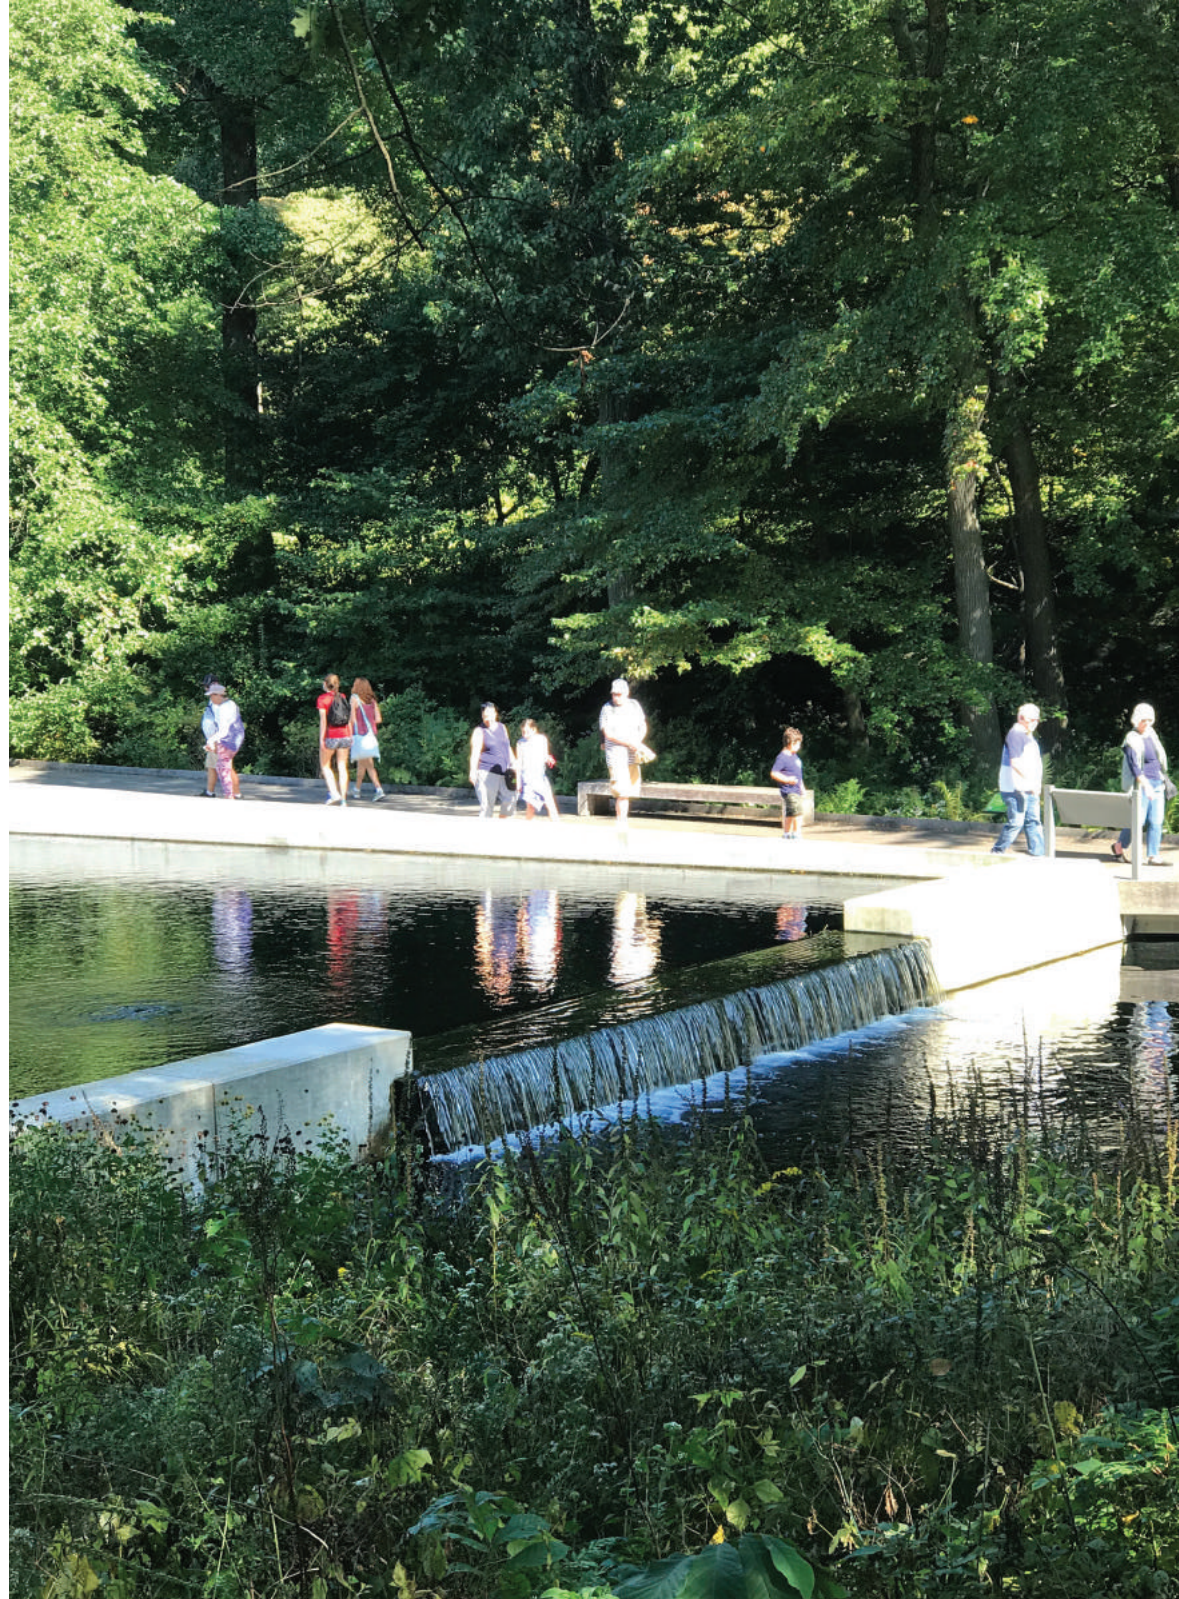
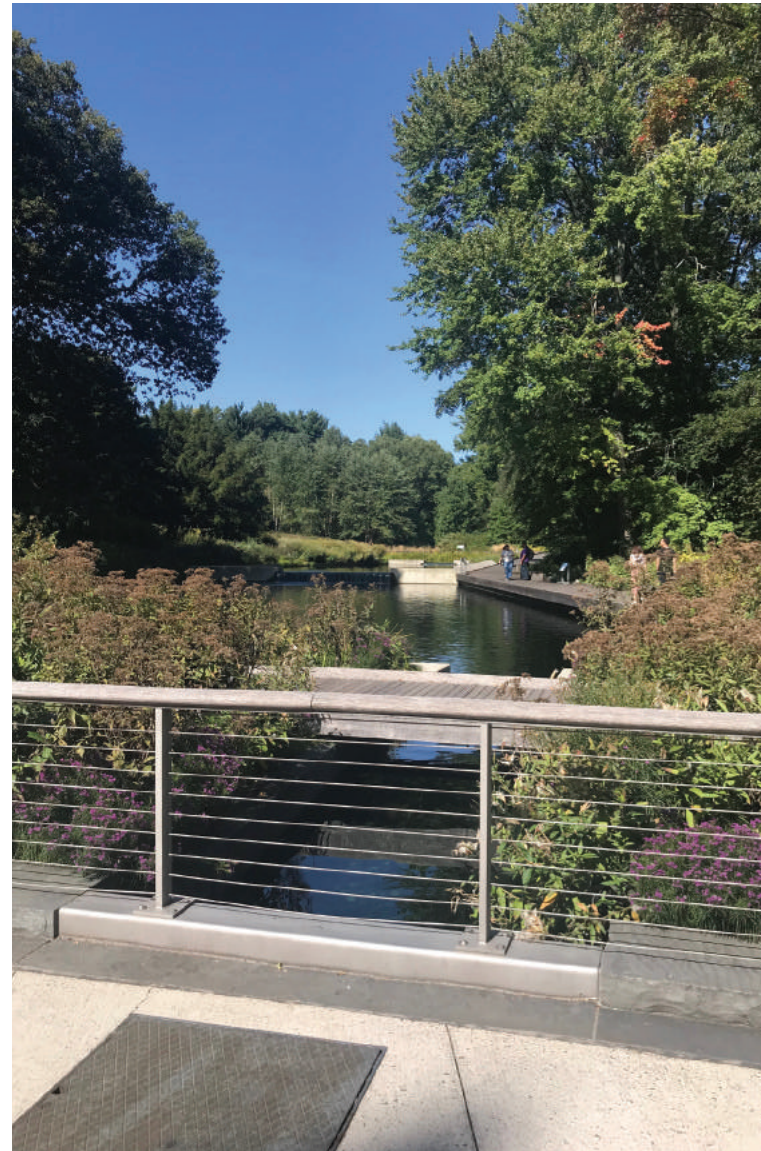
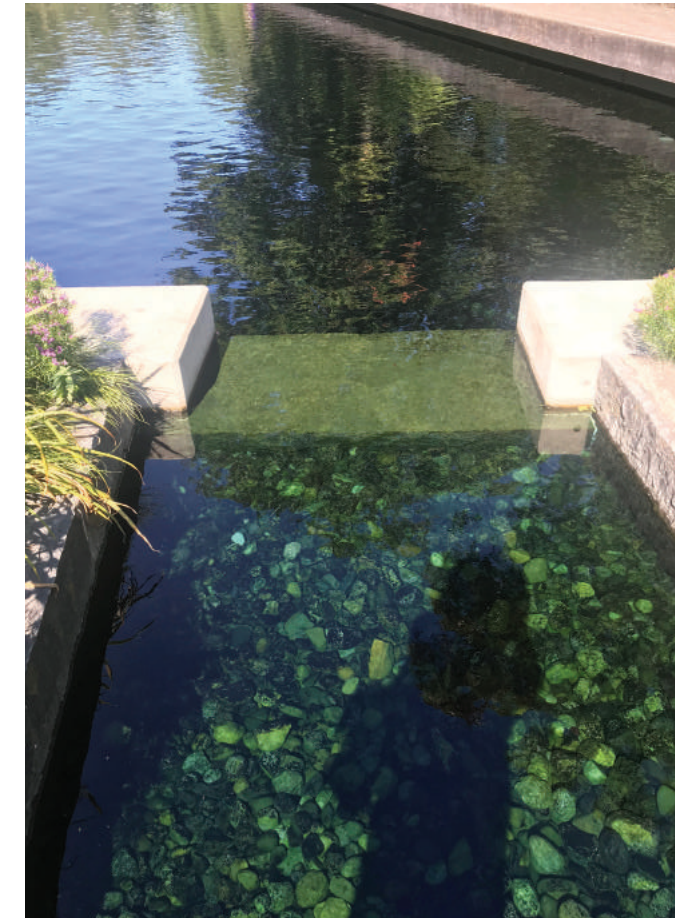
PHOTOS: left photo , close up of weir. Middle photo, railing and overpass with catch basin, right, close up of lowest basin leading to Wild Wetlands. photos by Alyssa Leal Moffitt

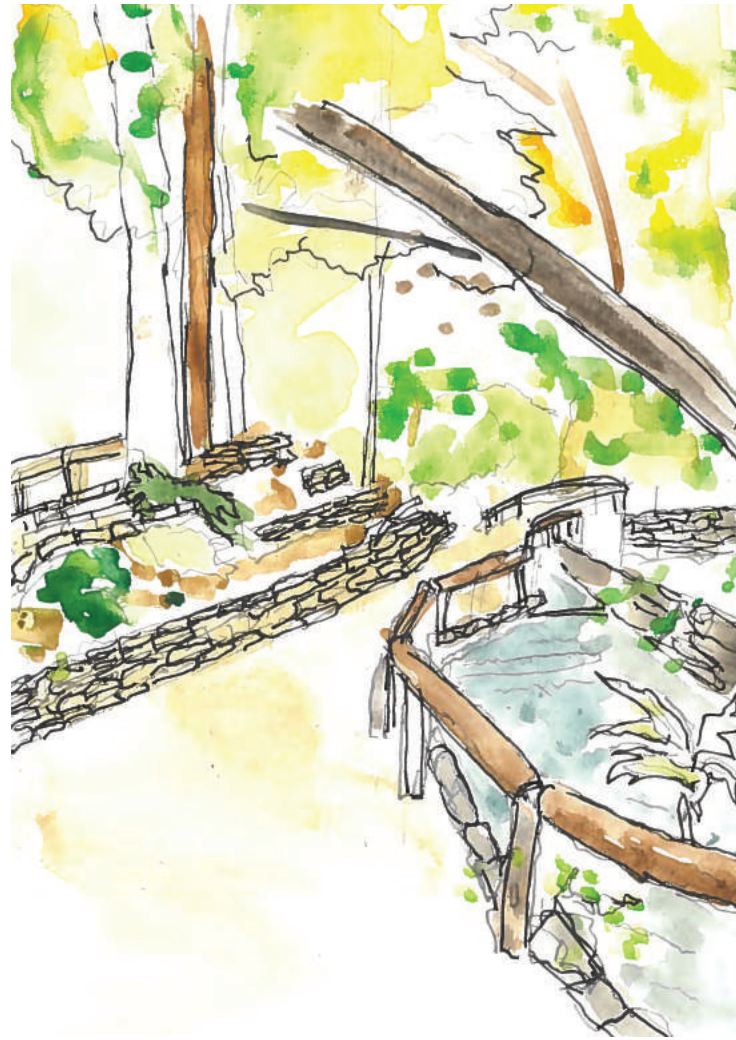
Rockery retaining walls and faux bois railings along the stream.

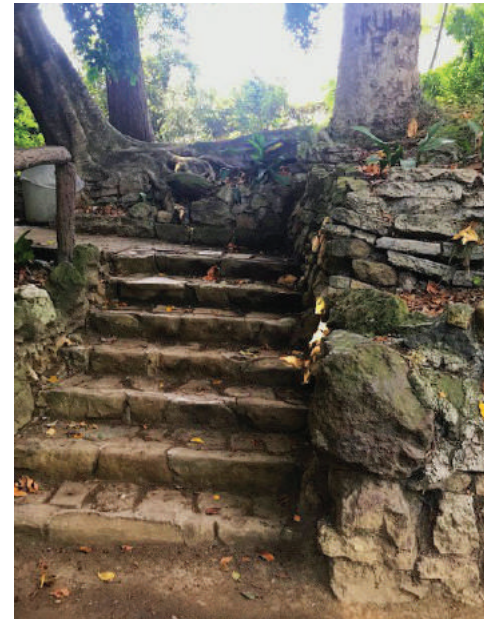
Stone stairway

The photo at top right is of the stairway, the lower right photo show the wall from the drawing at lower left.

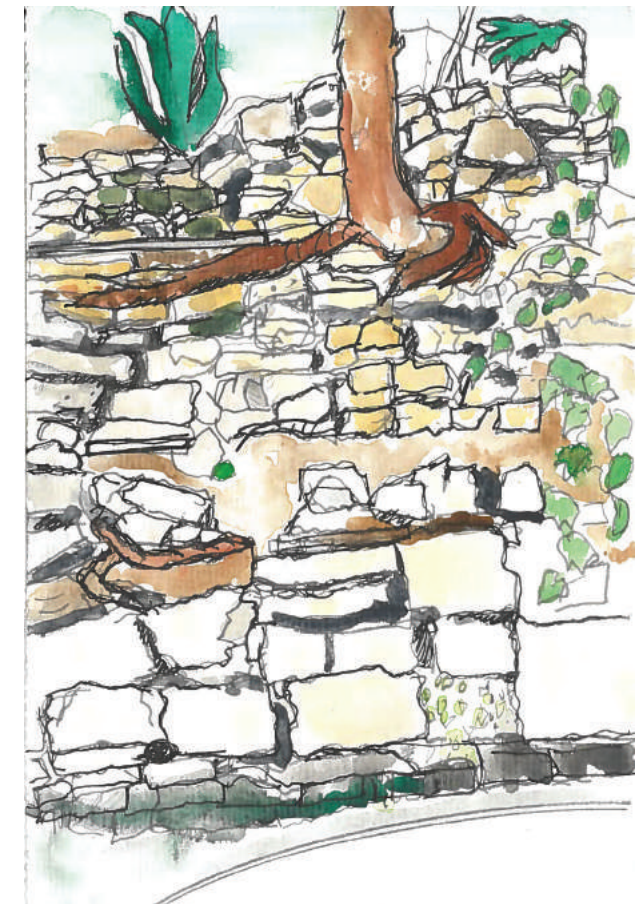
Perspective drawing of portion of wall with root intrusion.

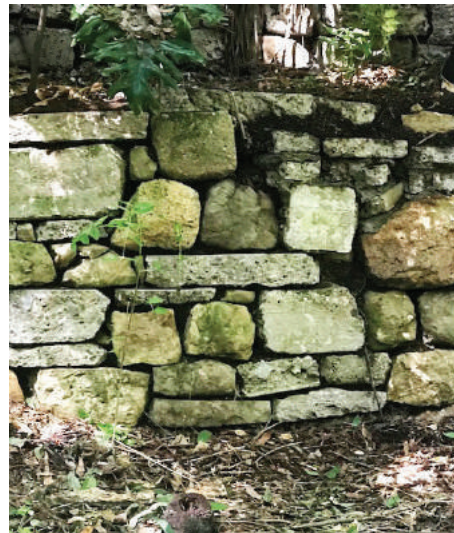
Original Dry stack stone wall with portions of broken sidewalk within original wall and above.

The walls vary greatly in material and craftsmanship. (See Enlargement page for photos). This in itself is appealing and tells the story of the New Deal era. But the addition of broken sidewalk (sometimes called urbanite) is an anacronism that appears hastily executed and poorly considered.

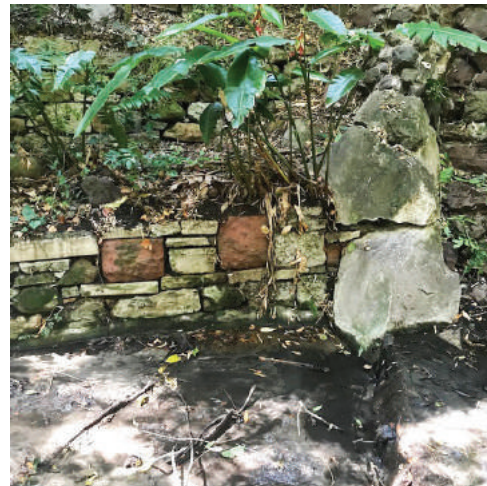
Dry stacked stone with larger stones to right.

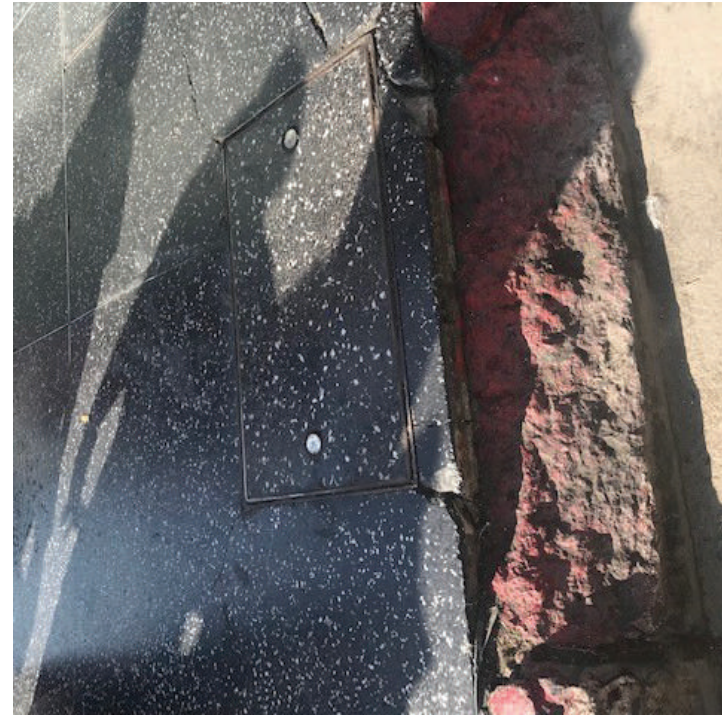
Broken curb interface with terrazzo pavement. Broken divider.

- 1) control joints in the concrete slab being covered and not telegraphed through the terrazzo assembly.
- 2) Terrazzo divider strips not fully bonded and supported by epoxy in order to leave no voids. When the epoxy moves the terrazzo cracks in these areas.
- 3) The original cement slab was either not completely flat or was subjected to high levels of moisture.
- 4) The concrete slump was high.

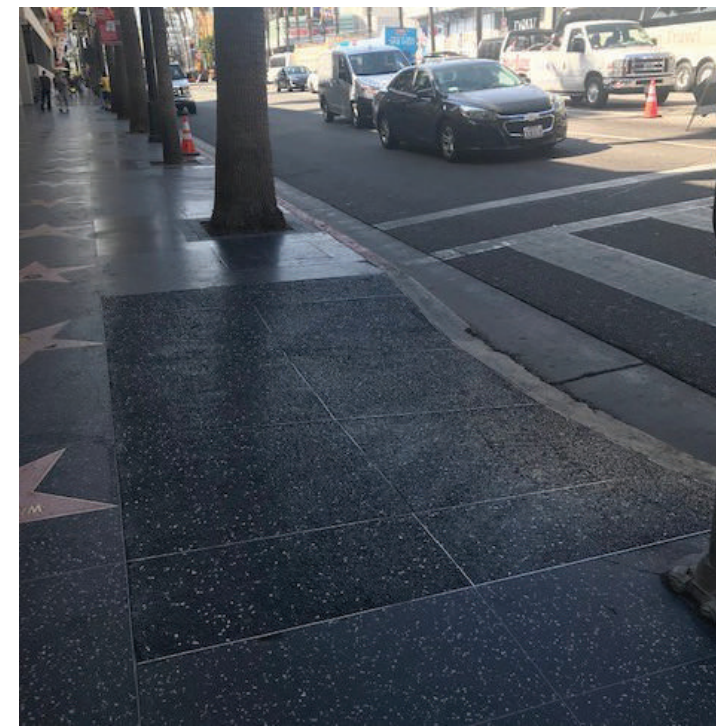
Terrazzo and curb with black concrete divider.

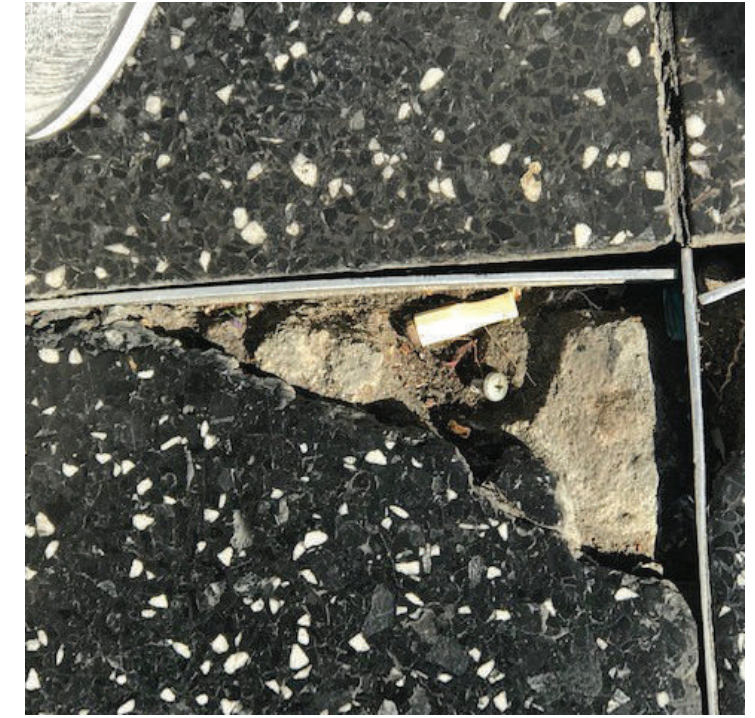
Detail of broken terrazzo and warped dividers.

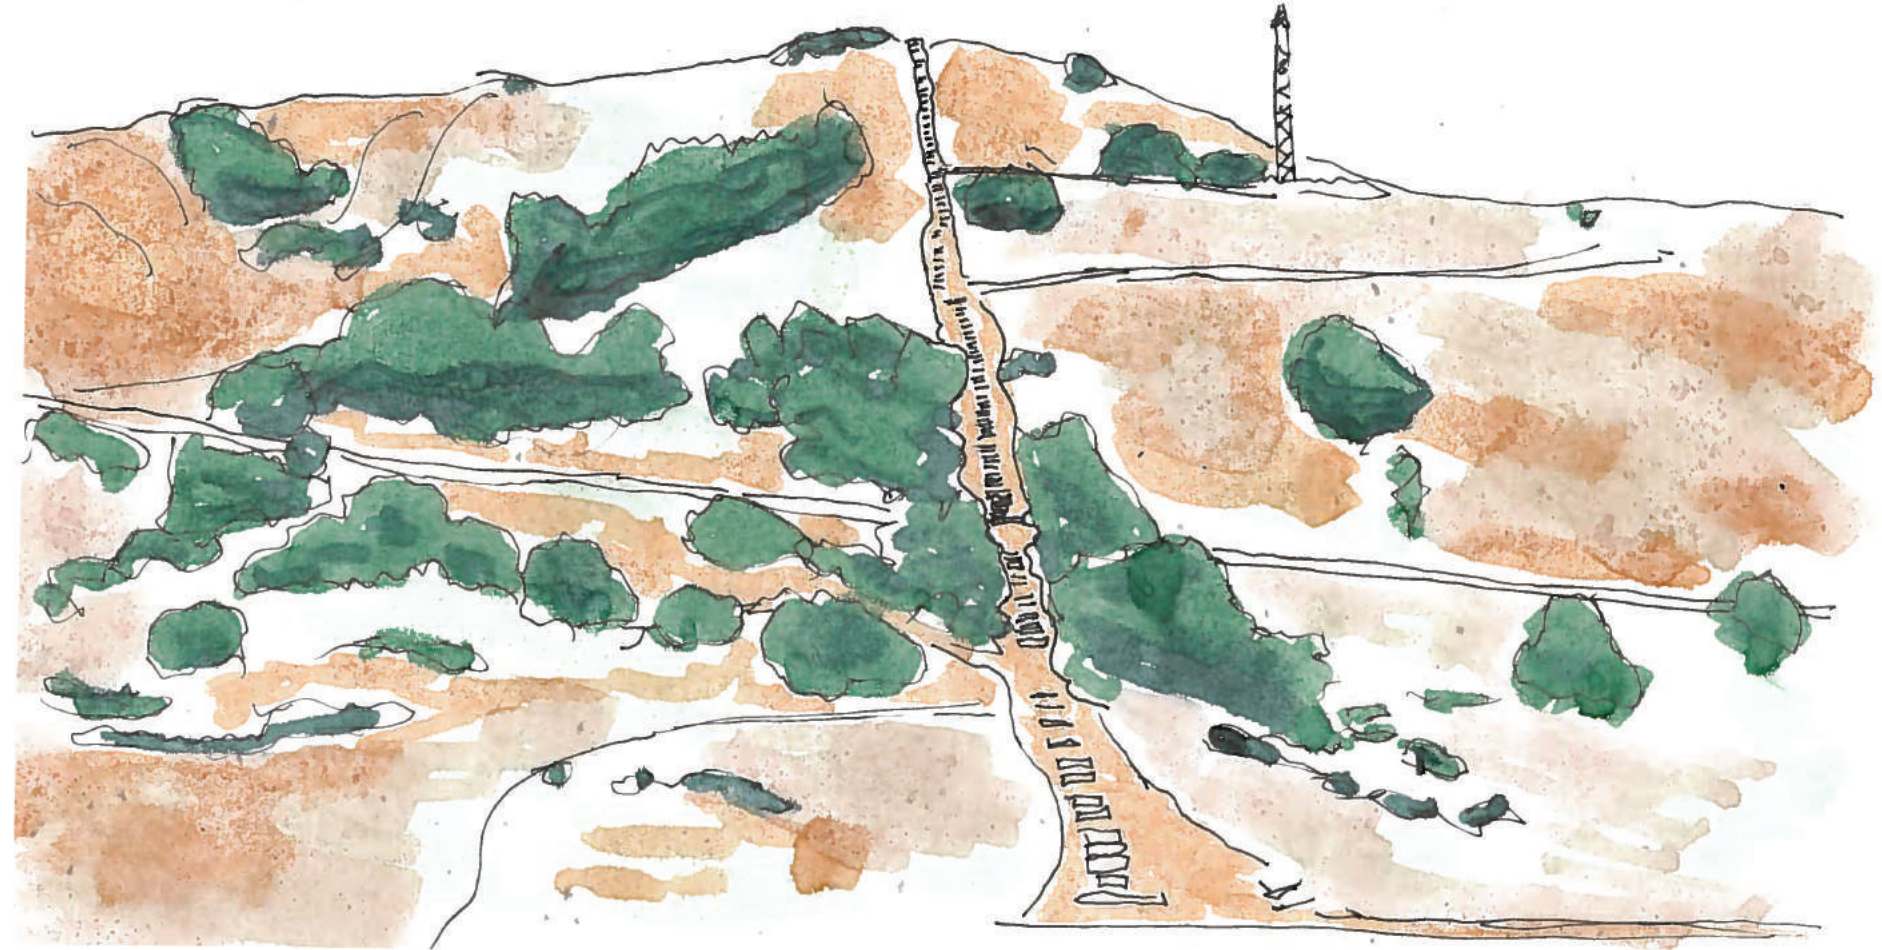
CULVER CITY STEPS

A perspective of the Culver City Steps leading to the Baldwin Hills Scenic Overlook. To the right is a cellular tower. The mountain is steep and sparsely vegetated, still undergoing a long restoration process

The example here is of a 20" rise, 4' tread. Commonly on steep slopes stairs have a higher rise and a shorter tread. The treads of the Culver City Stairs are all particularly wide and must be due to avoiding any grading on a degraded site and to the material.

The stairs here and in the garden by the visitor center are made of broken concrete of which there is an abundance left by the previous developer. The depth (sidewalk depth) is approximately 2" which may be layered with a low slump concrete. I assume here that #4 rebar approximately 8' is driven into the hillside.

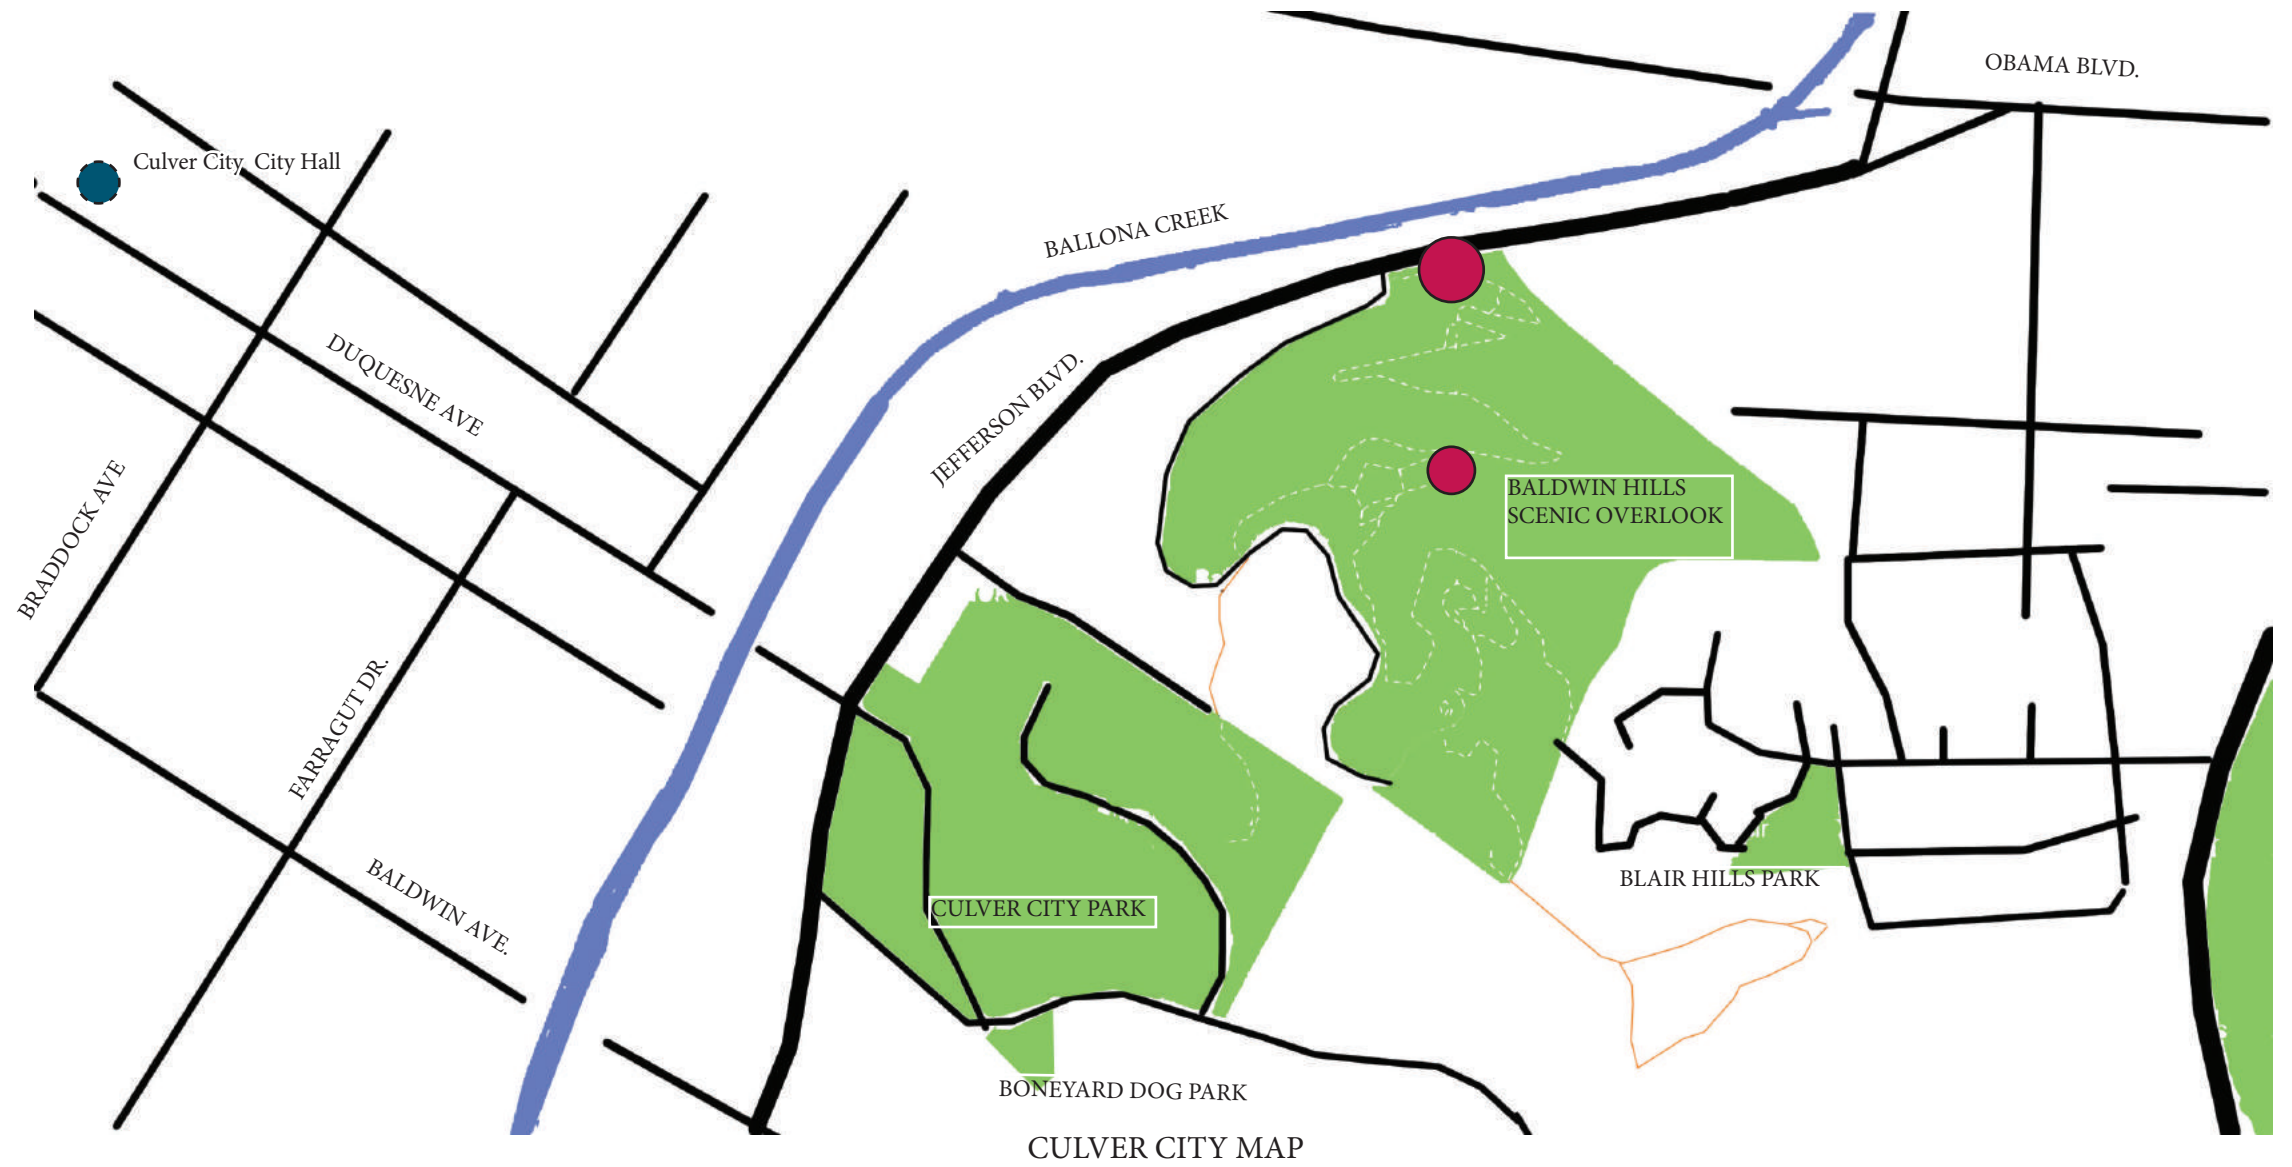
BALDWIN HILLS SCENIC OVERLOOK MAP:

- A. Parking Lot
- B. Visitor's Center
- C. Garden Path
- D. DG Path
- E. Overlook
- F. DG Hiking Path
- G. Entrance
- H. Hetzler Road
- I. Jefferson Boulevard

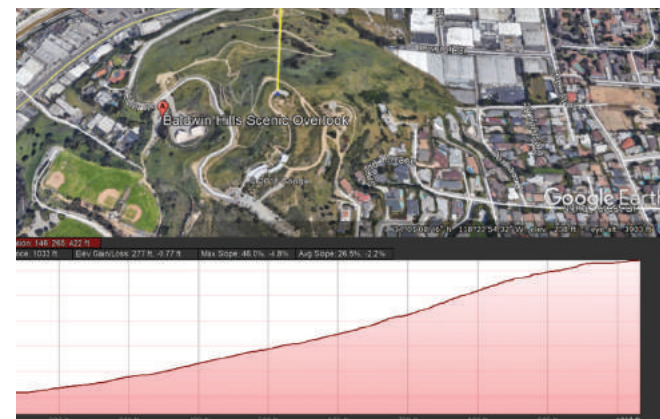
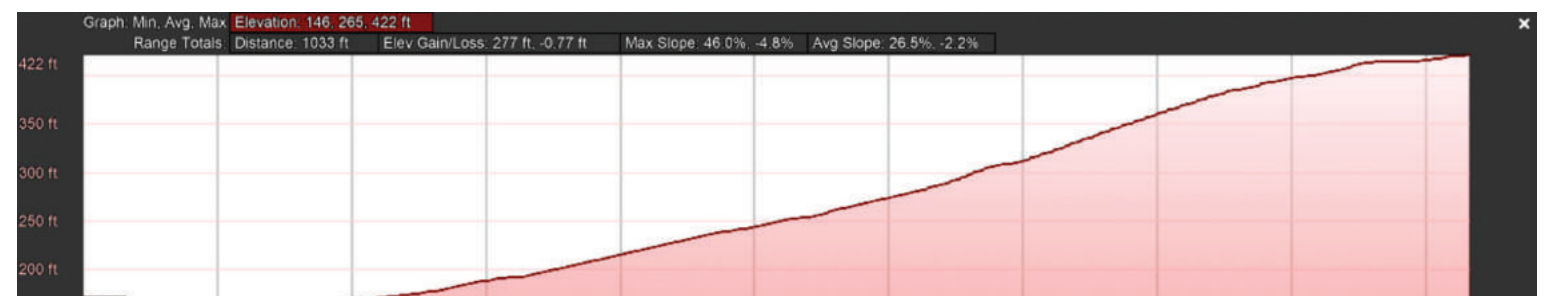
GOOGLE EARTH CURVE ANALYSIS

Using Google Earth path analysis one can roughly measure the elevation and distance of a path- in this case the Culver City Stairs. It is often stated that the elevation change is 715 feet covered in 285 stairs. This would be a 1:2 slope and not feasible. It appears that 715 feet may be the horizontal distance (here it is given as 1033 feet) with an elevation change of 277 feet. The slope would then be closer to 38% if the distance is 715 and 27% if it is 1033 feet.

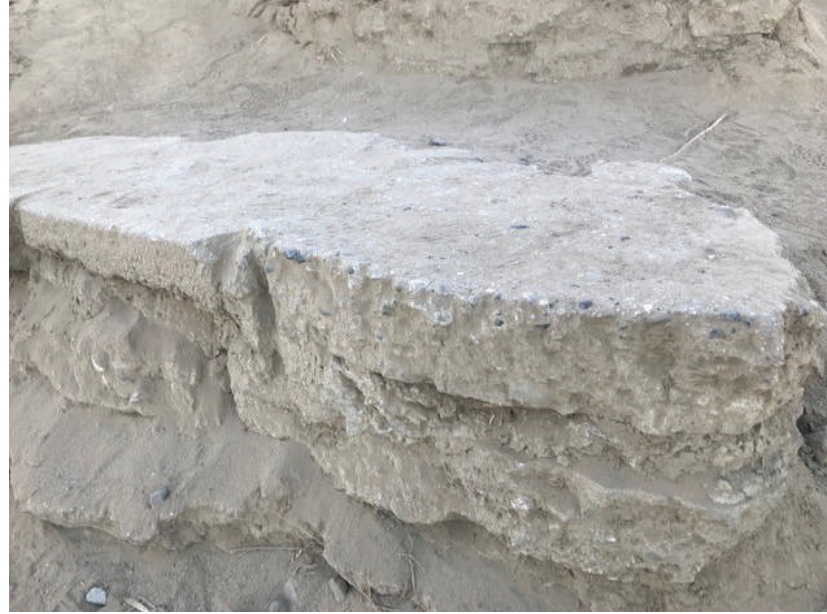
Stair detail  
4-6 layers of 2" broken sidewalk

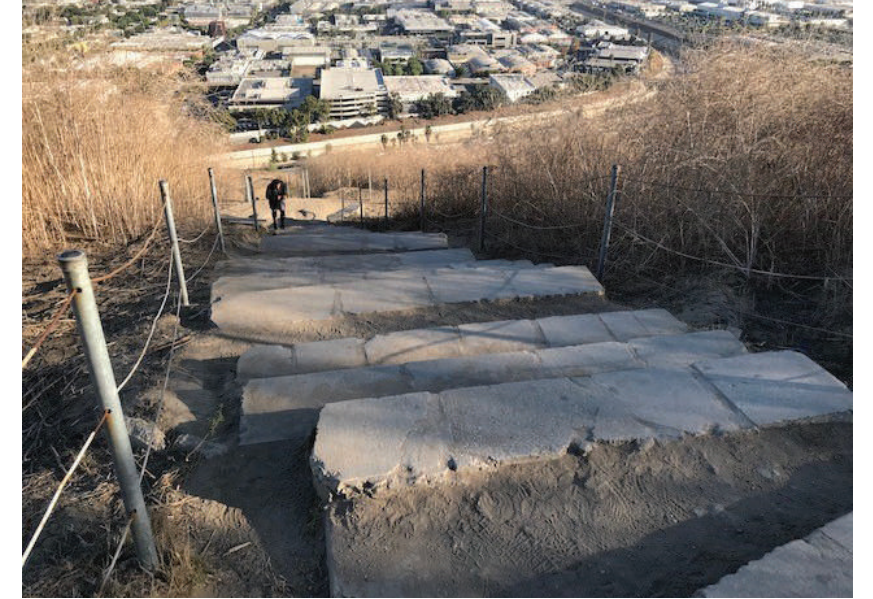
Stairs from above  
Wide tread with dirt

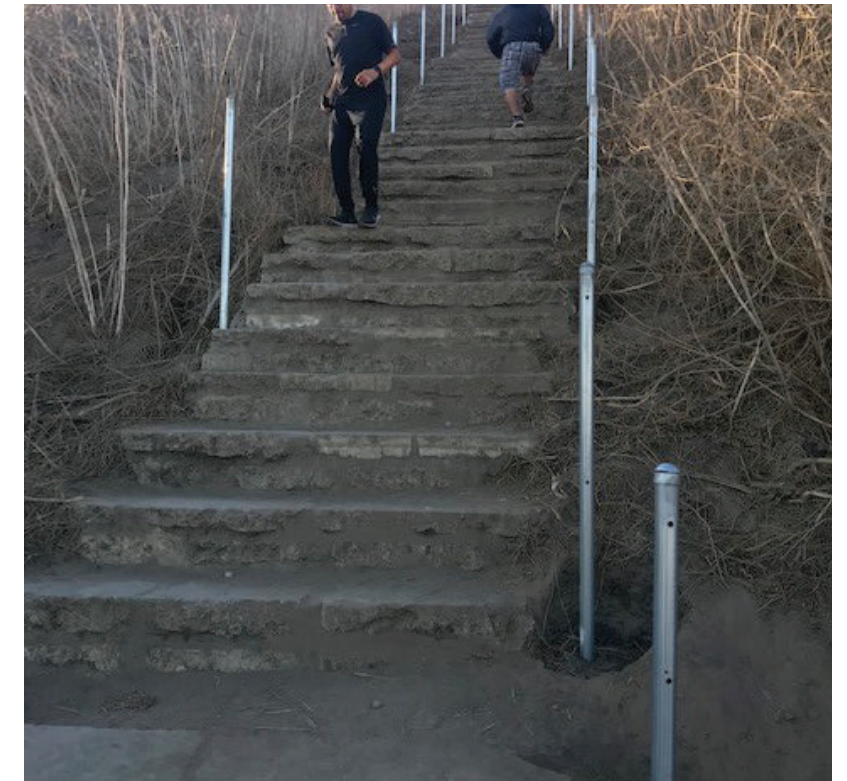
New railing being installed

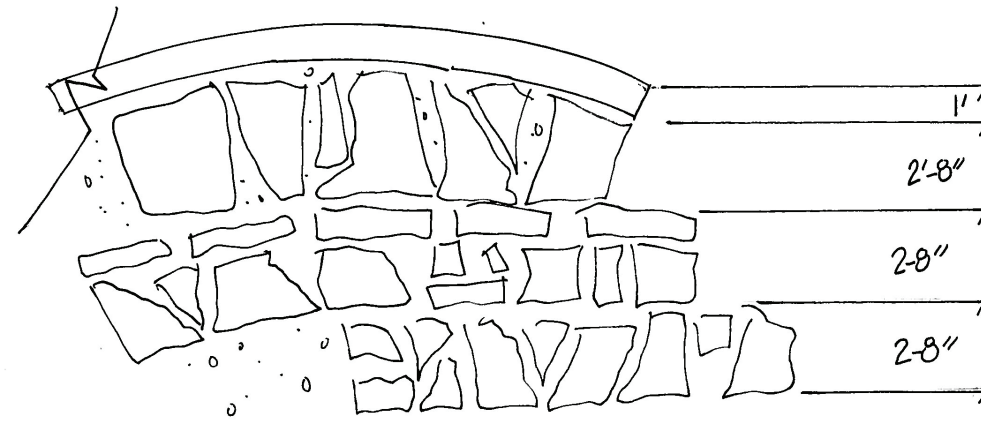
GARDEN STEPS  
PLAN

The steps leading from the DG paths around the Visitor Center to the small garden are also made of broken sidewalk but the pieces are organized into patterns and are inset into DG. They appear not to be mortared together. The rise is a uniform 4" and the width varies but starts at 2'-8". The entrance from the west building DG Path has a concrete arc of 1' depth and 55'-6" length and gently transitions from the rectilinear buildings to the curvilinear paths of the garden and the nature trails. The decomposed granite is held in place with plastic edging. On the lower curve of the path there is considerable erosion and there appears to be no grading.

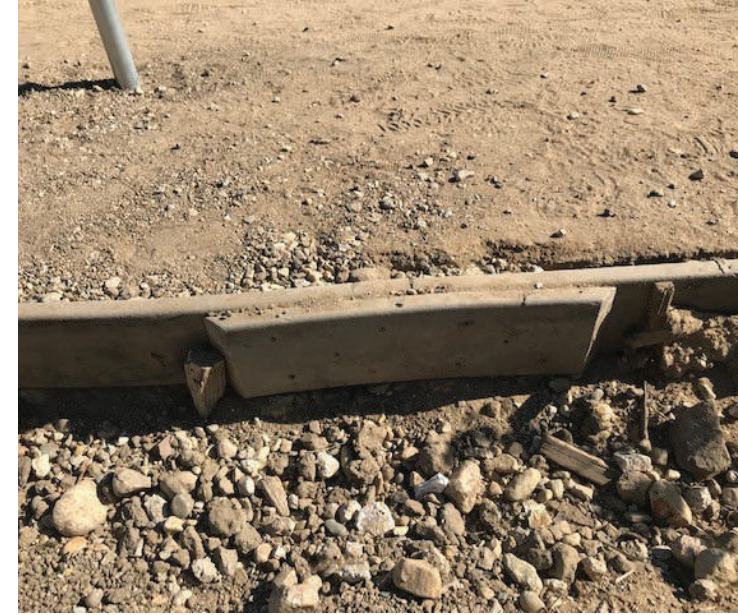
Edging detail

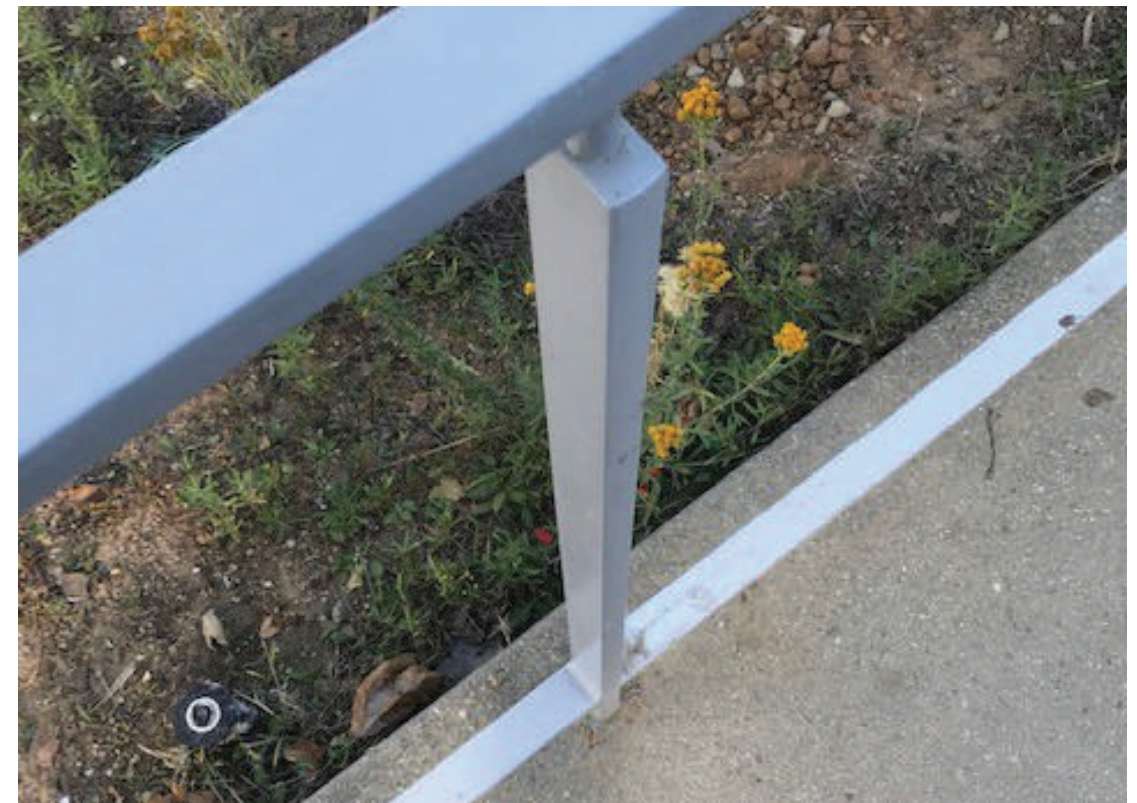
Detail of post connection on rail

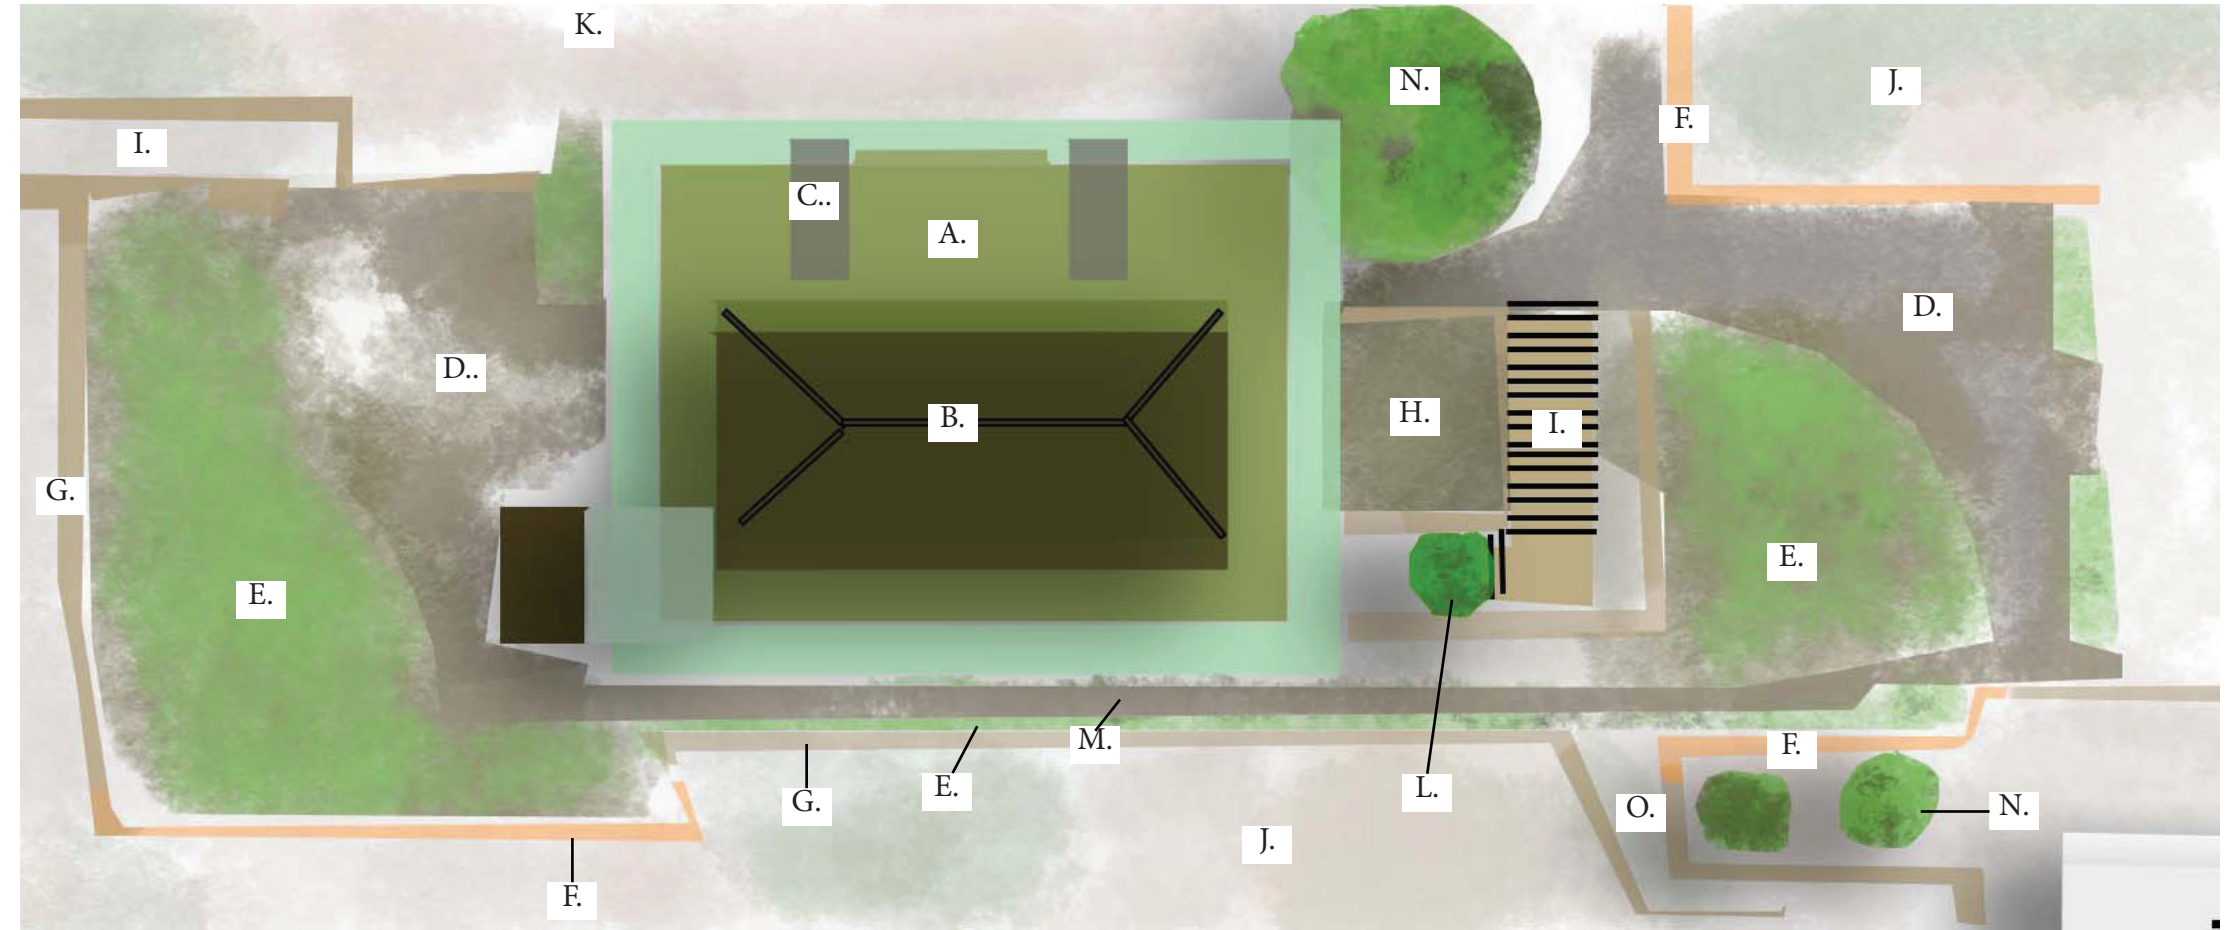
ADAMS CENTER FOR THE ARTS

The enlargement on this page is of the Adams Center for the Arts. This building has two levels of roof gardens; the roof of the second floor is inaccessible but the first floor intensive roof garden is accessible and has walking paths. The plantings vary from Mediterranean and native plantings alongside the edges to sedum and dyamondia plantings along the walkways by the classrooms. The second floor has clear views of the rooftop of Winter Hall. The building has remarkable oversized planters and unique exterior modern art exhibits.

The intensive garden design on the top floor load is 100 psf. HOW DO I SAY THIS???
