# CONSTRUCTION MATERIALS

Alyssa Moffitt  
Fall 2019

STORMWATER MANAGEMENT  
NEW YORK  
BOTANICAL GARDENS

NATIVE GARDEN  
WETLAND &  
RETENTION BASIN

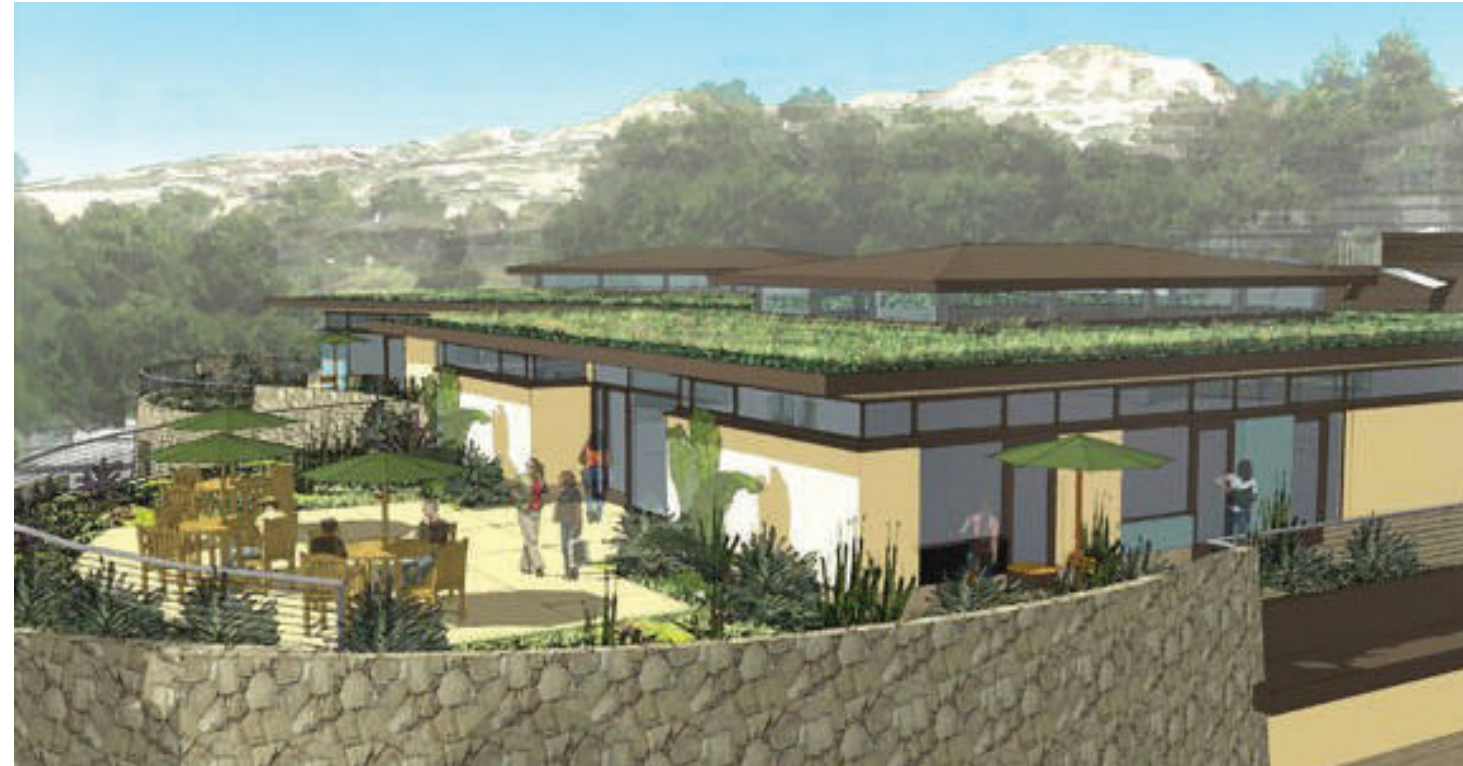
UPPER ROOF GARDEN  
2nd floor roof garden and rock wall  
Blackbird Architects Sketch Up Drawing

Here are two Sketch Up drawings from the Blackbird website. .

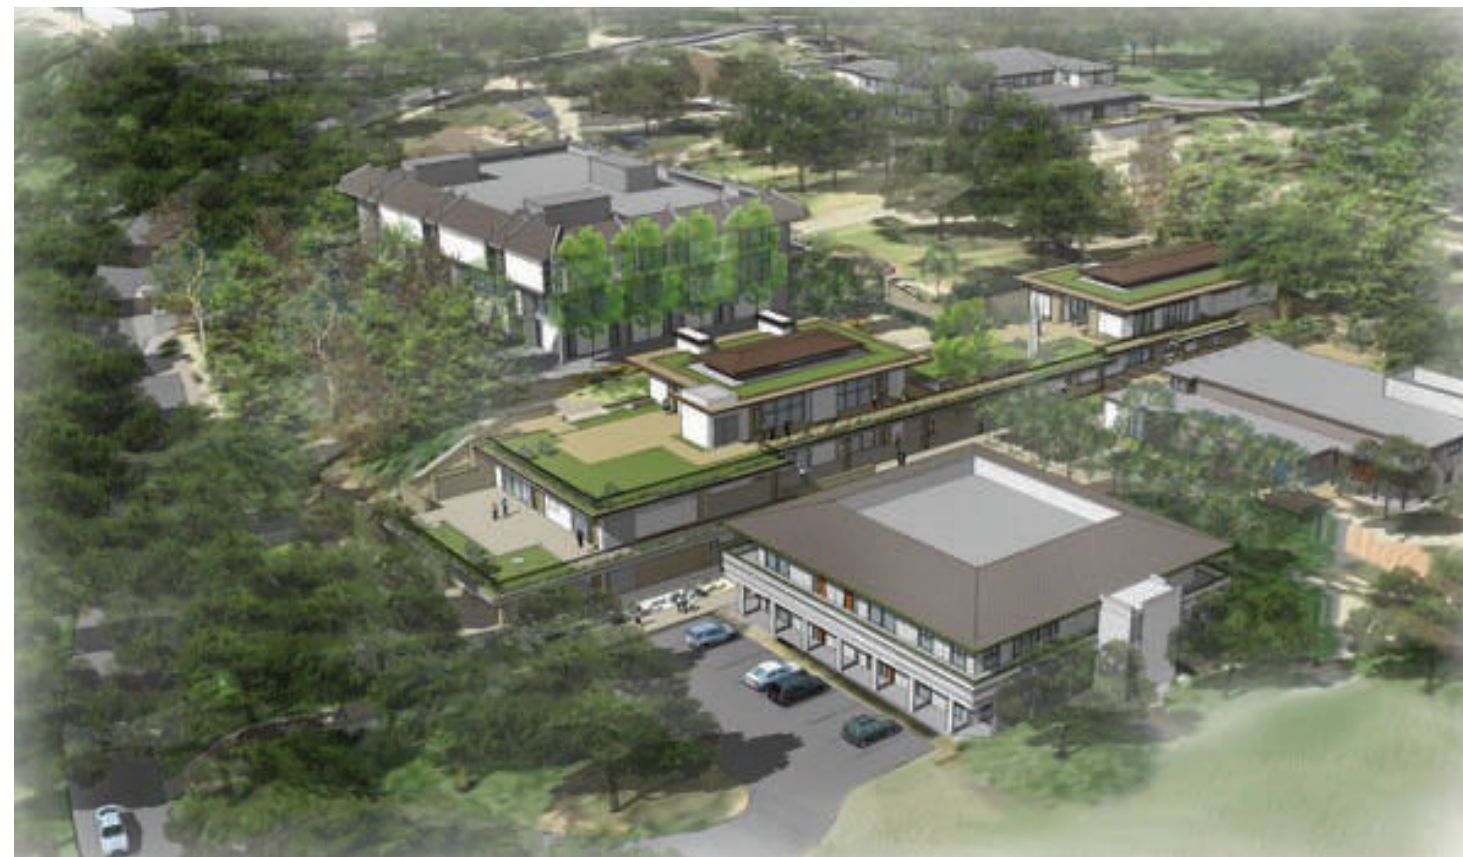
ADAMS CENTER FOR THE ARTS  
Sketch Up from Masterplan by Blackbird Architects

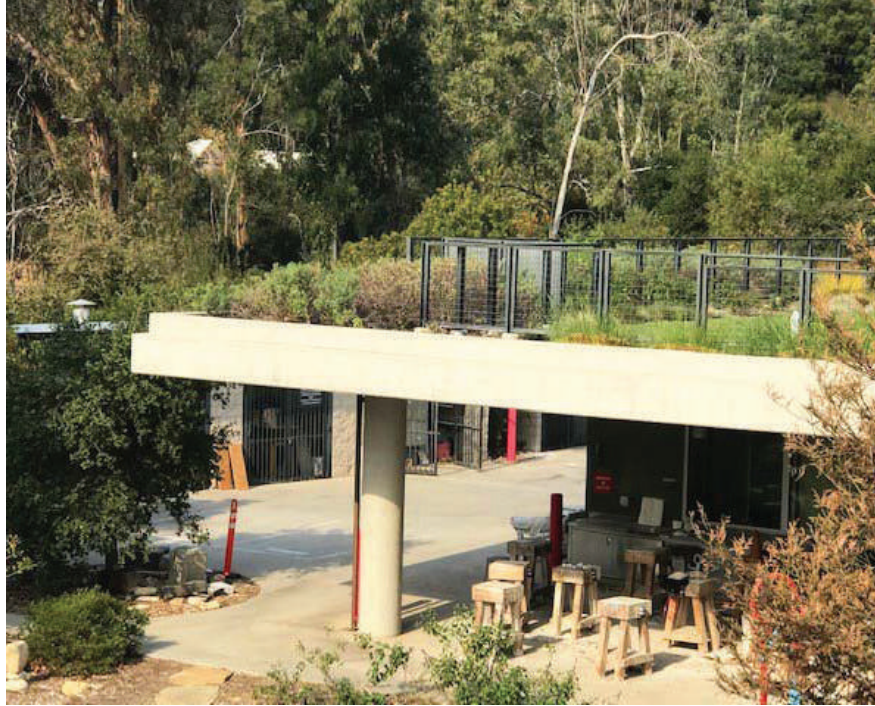
2nd floor roof garden and column with drain

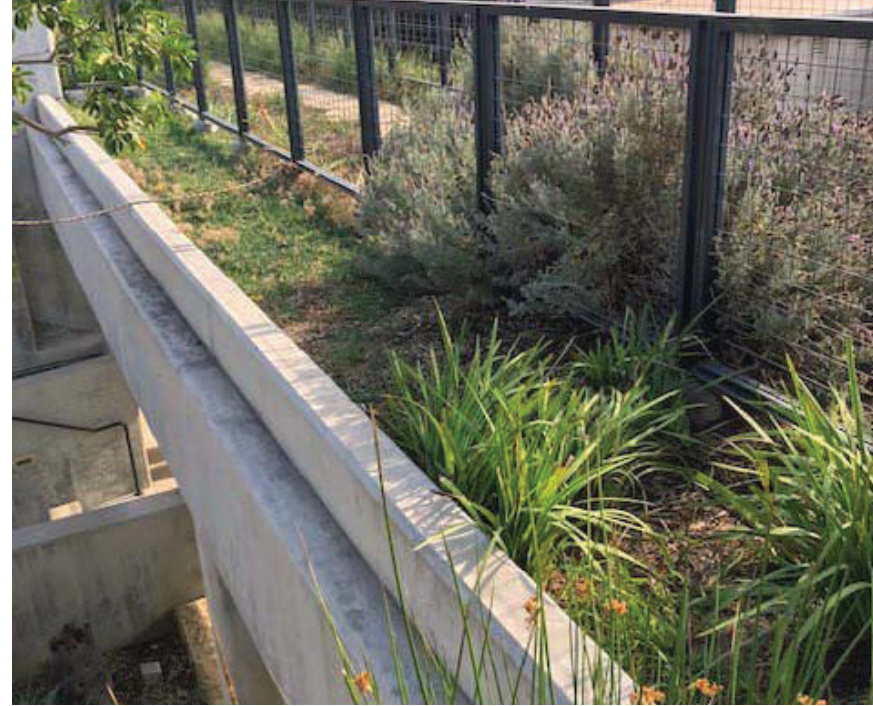
Close up of 2nd floor roof garden edge

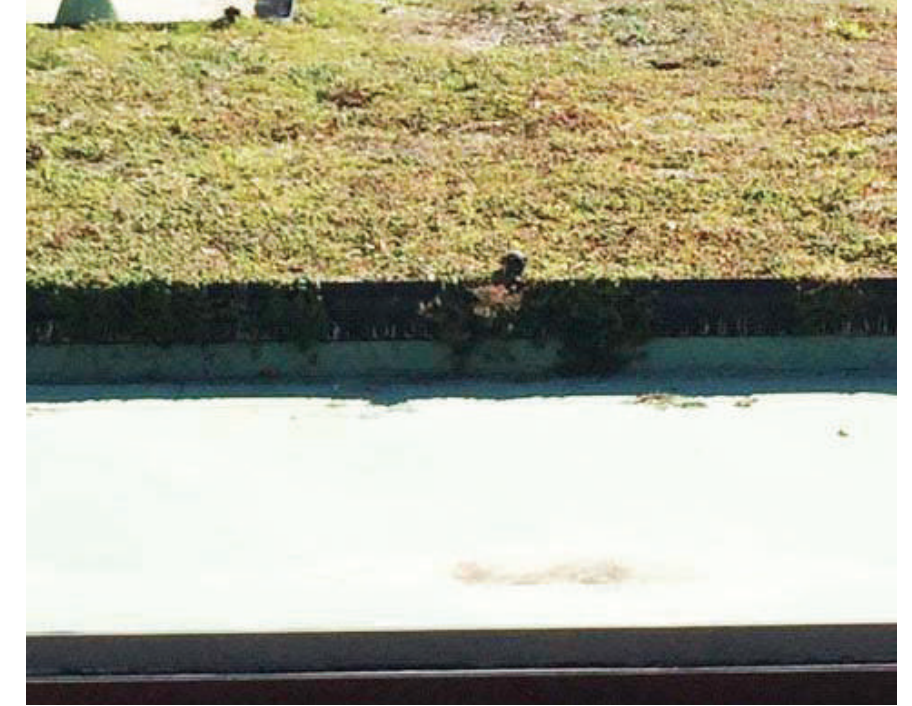
Close up of Winter Hall intensive garden  
The draining layer is visible above the root barrier and  
elastomeric moisture barrier

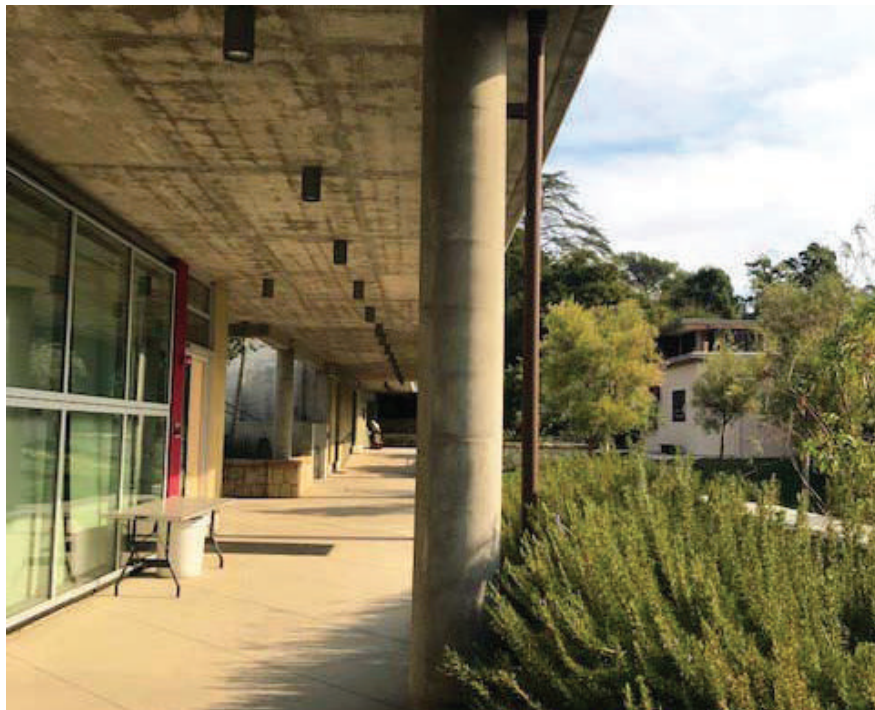
Column close up with drainage

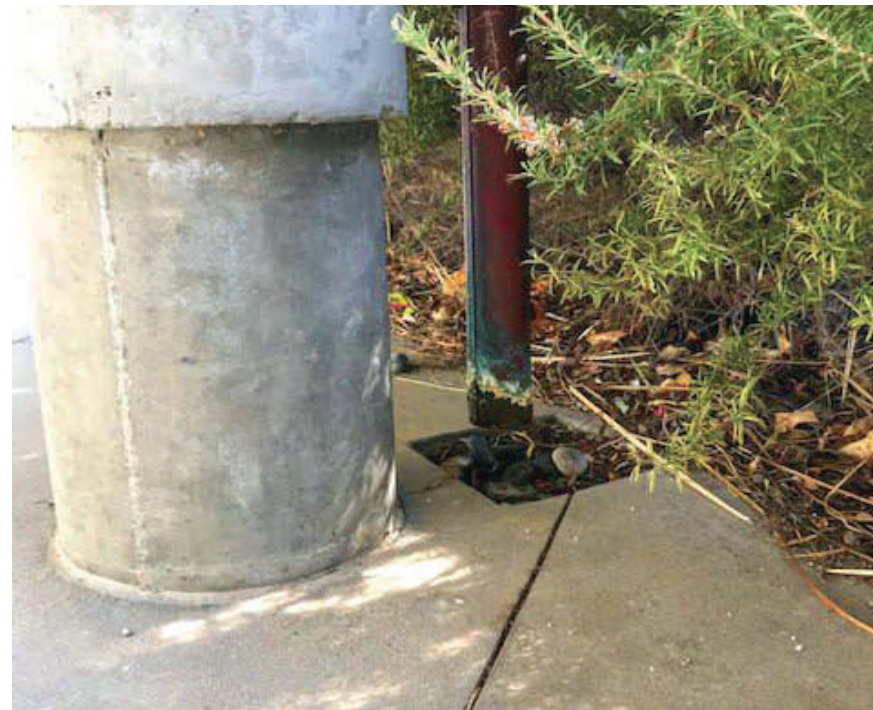
Close up of drainage into catch basin

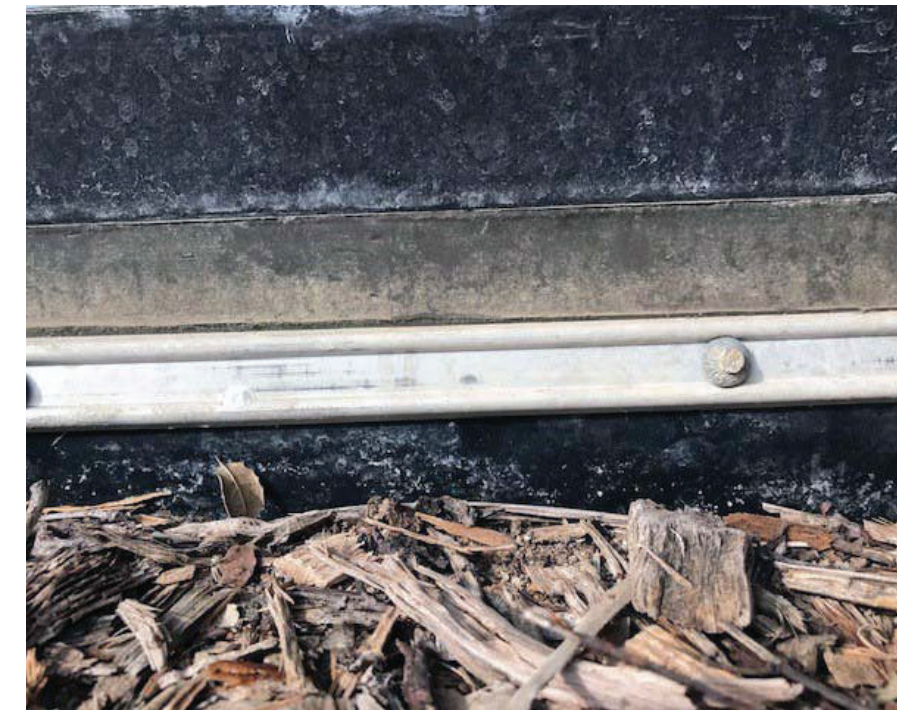
Flashing detail  
root barrier (black) also visible

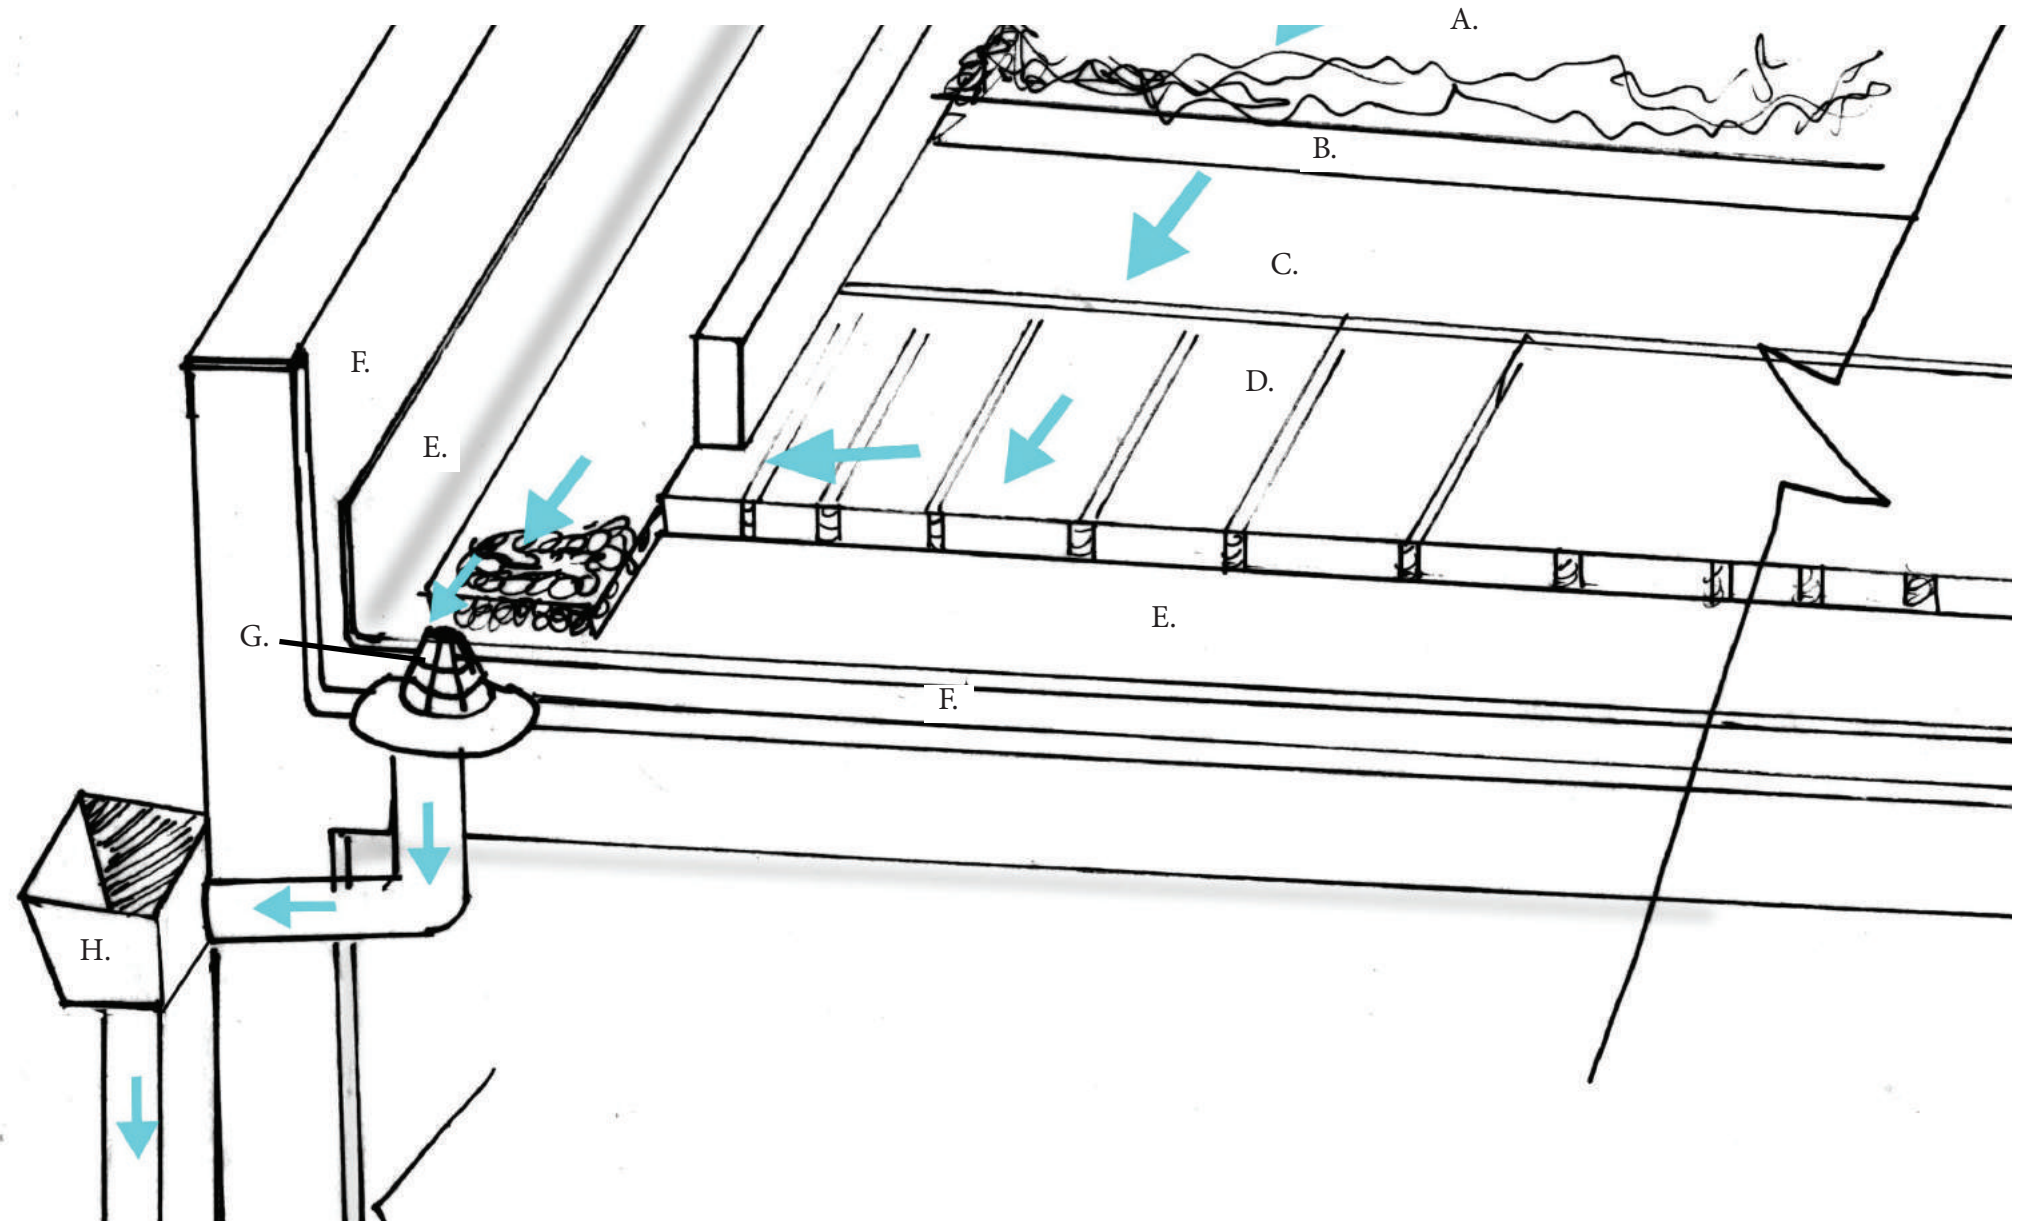
DRAINAGE SCHEMATIC:

- A. Planting
- B. Mineral Planting medium
- C. Filter Sheet
- D. Drainage board
- E. Protection mat
- F. Root barrier
- G. Drain
- H. Downspout
